Outstanding Items Report – 11/04/2020

Project: Niles Barnard Renovation Project
Project No: 0128-18-0020
Date: November 4, 2020

Owner: City of Troy

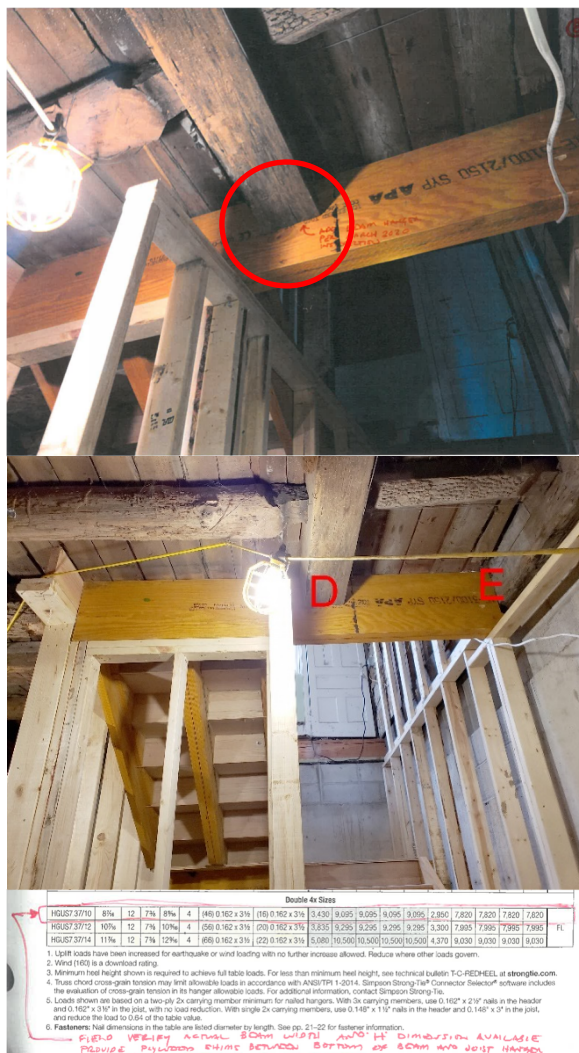
1. Items from 2020-03-18 Site Observation Report: Verification Photo:
 - a. Existing beam left unsupported at end. Provide beam hanger by Simpson Strong-Tie or KantSag to attach existing timber beam to new double LVL beam w/ beam hanger. (Labeled as "D" in photo below)
- Completed date: 2020 - - Verified by:

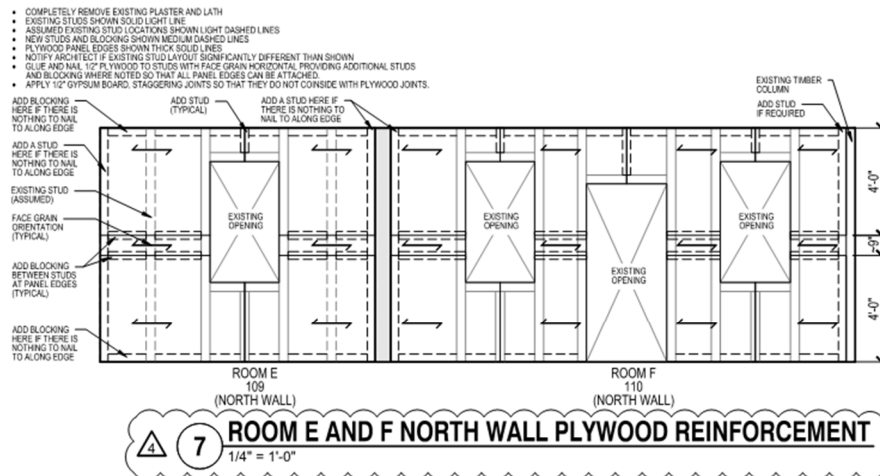
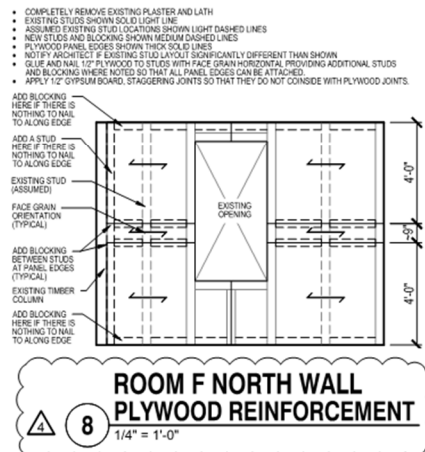
- b. Refer to details 7/A-211 and 8/A-211 (attached) for correct installation of sheathing
Completed date: 2020 - - **Verified by:**
2020-08-26: Unable to verify due to installation of gypsum board in affected areas, no verification photo provided by Cedroni.

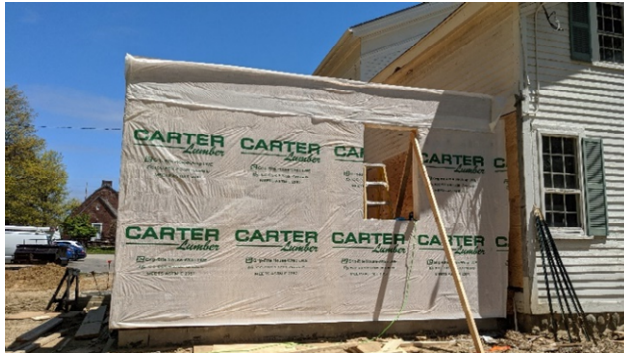
- a. Existing siding on northwest corner of existing building to be replaced with salvaged original siding and trim. (Photos below)

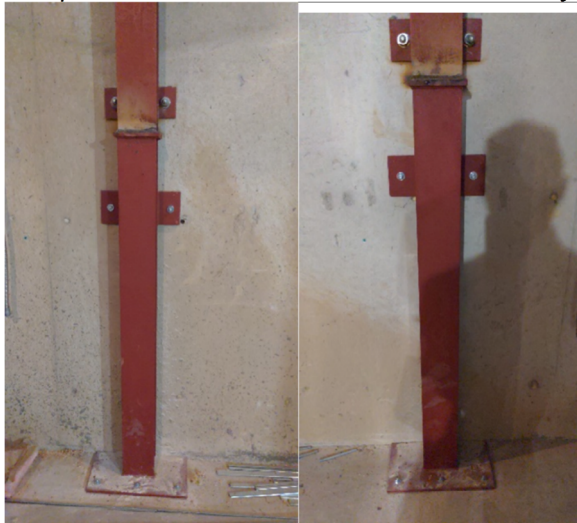
- a. Prepare surface of steel exposed during the course of welding and paint with rust inhibitive primer per specifications on sheet S0-1

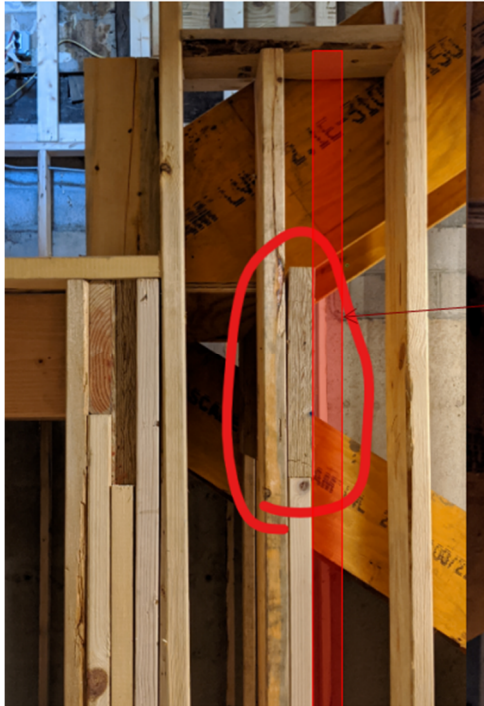
- a. LVL carrying stringer cracked at fastener locations, rotating under load.
Provide full height 2x full height, glue and screw to existing 2x and LVL, attach to blocking above at condition shown and similar at center of stair bearing location.

provide 2x full height, glue and screw to existing 2x and LVL, att to blocking above.

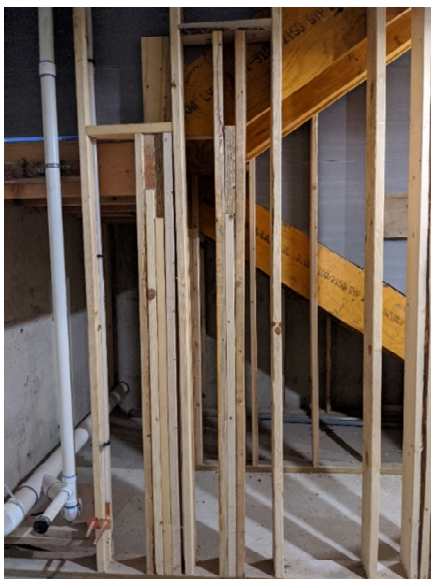
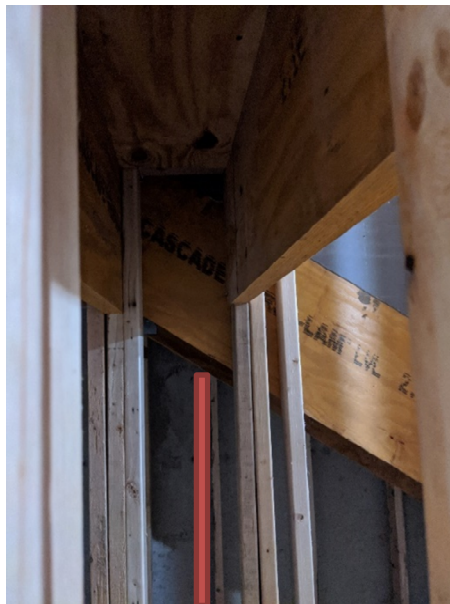
2020-08-26 Verification

2020-08-26: Partially complete, provide similar at center of stair bearing location as noted above.

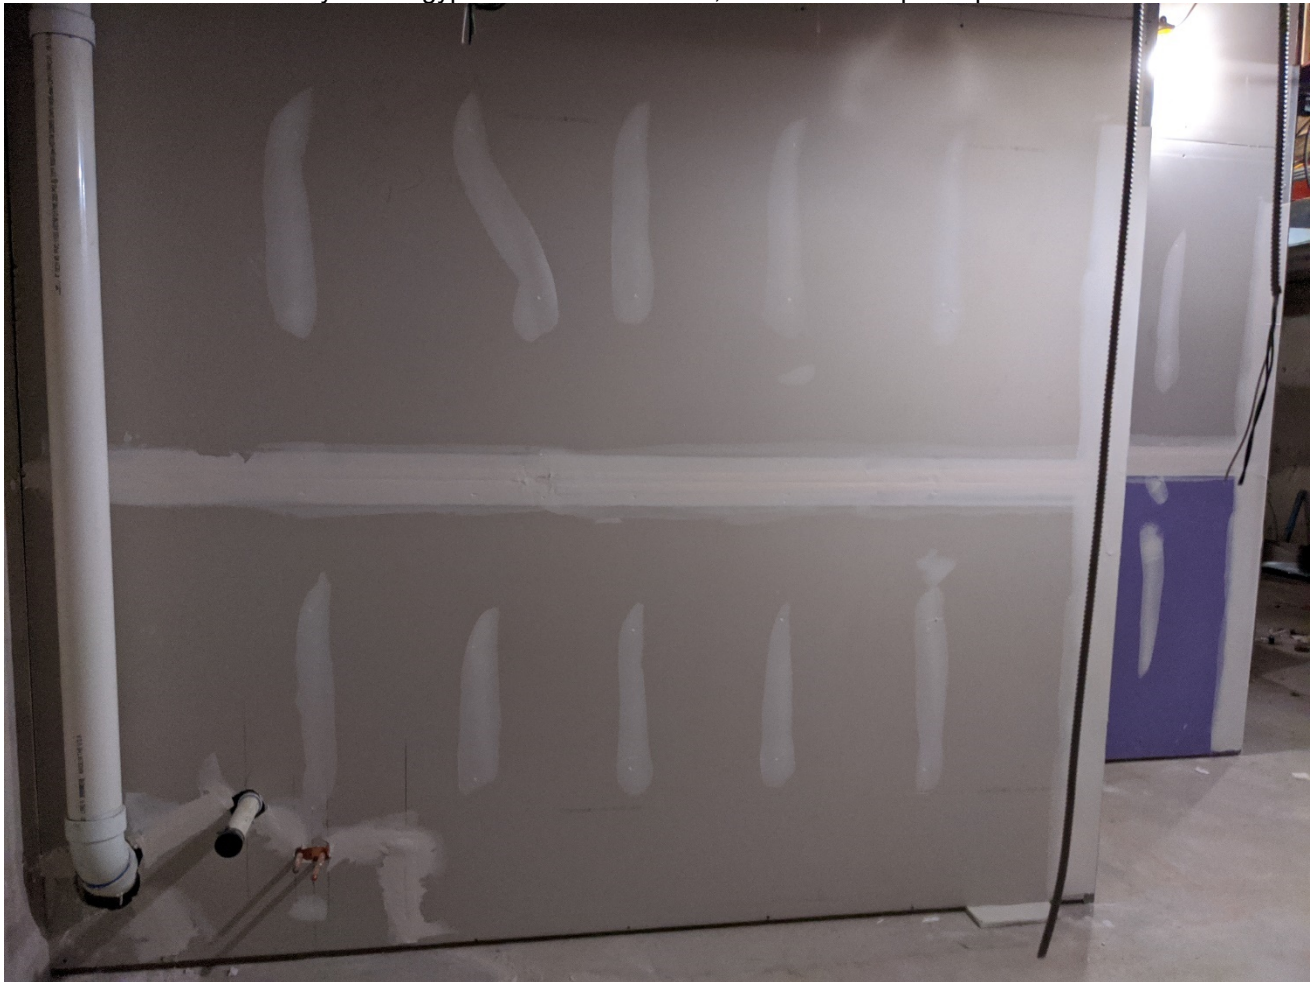
2020-09-02 Unable to verify due to gypsum board enclosure, no verification photo provided.

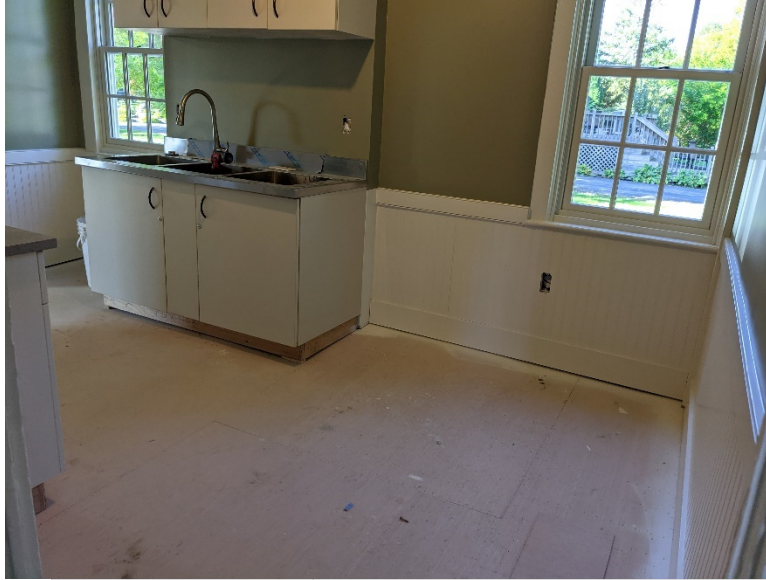
- a. Base cabinets in Room D (113) do not have plastic laminate bases per shop drawing markups.

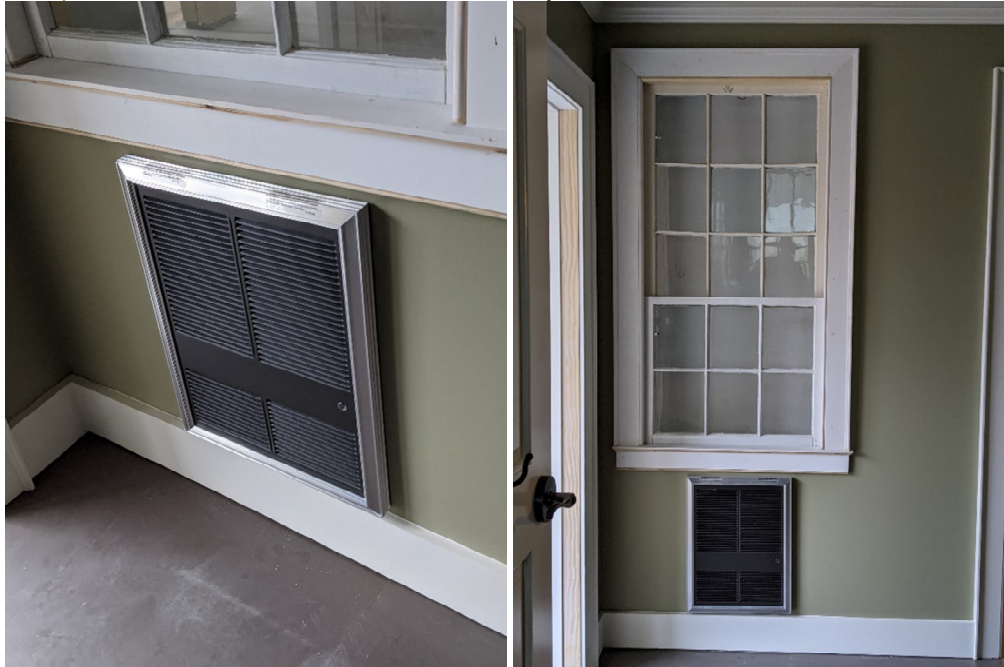
- a. **CUH below display window black with aluminum trim; Replace trim kit with Bronze**
Completed date:2020 - - Verified by:

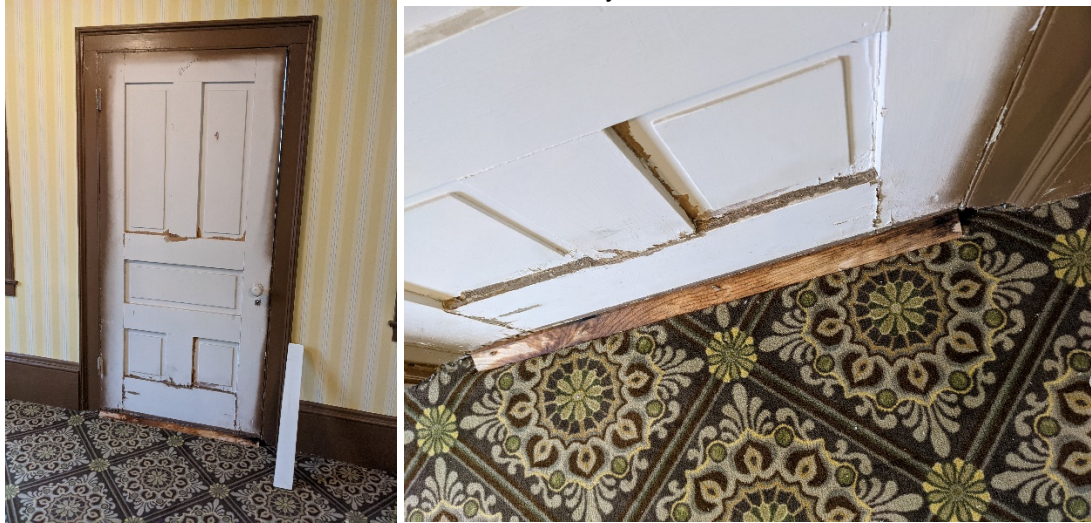
b. Address water intrusion at threshold of door 103A

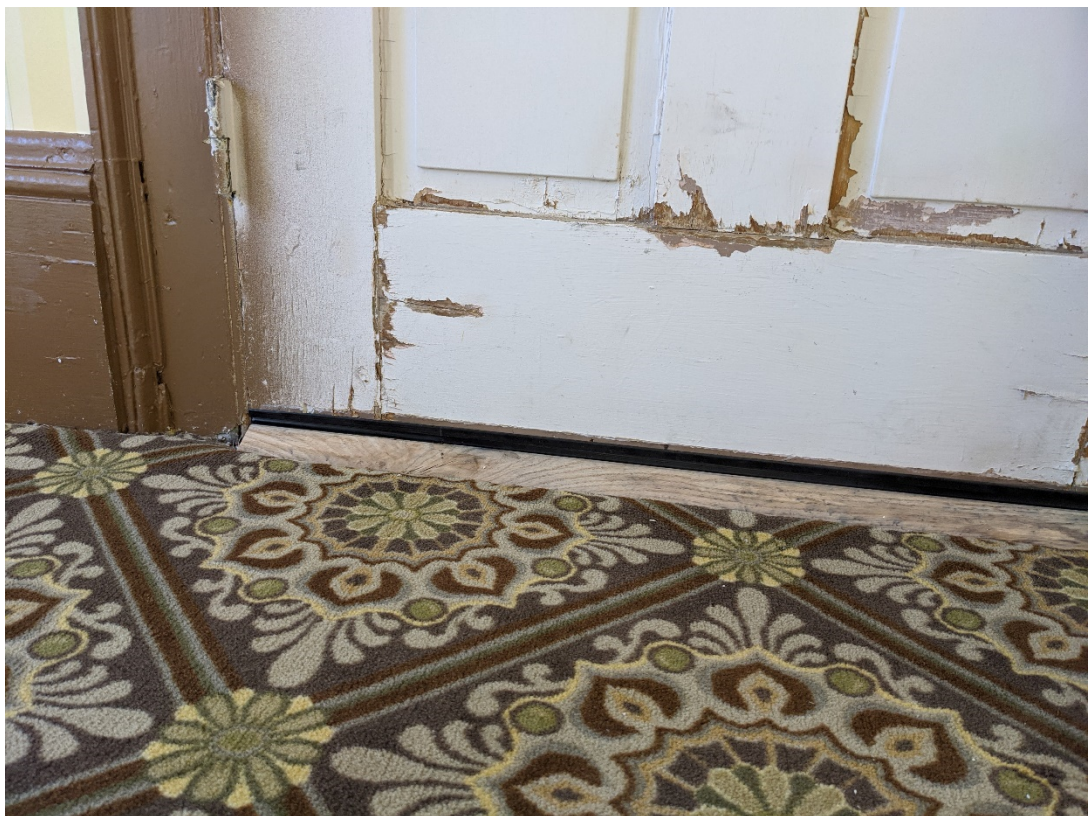
Verification Photo – Gasketing added to bottom of door.

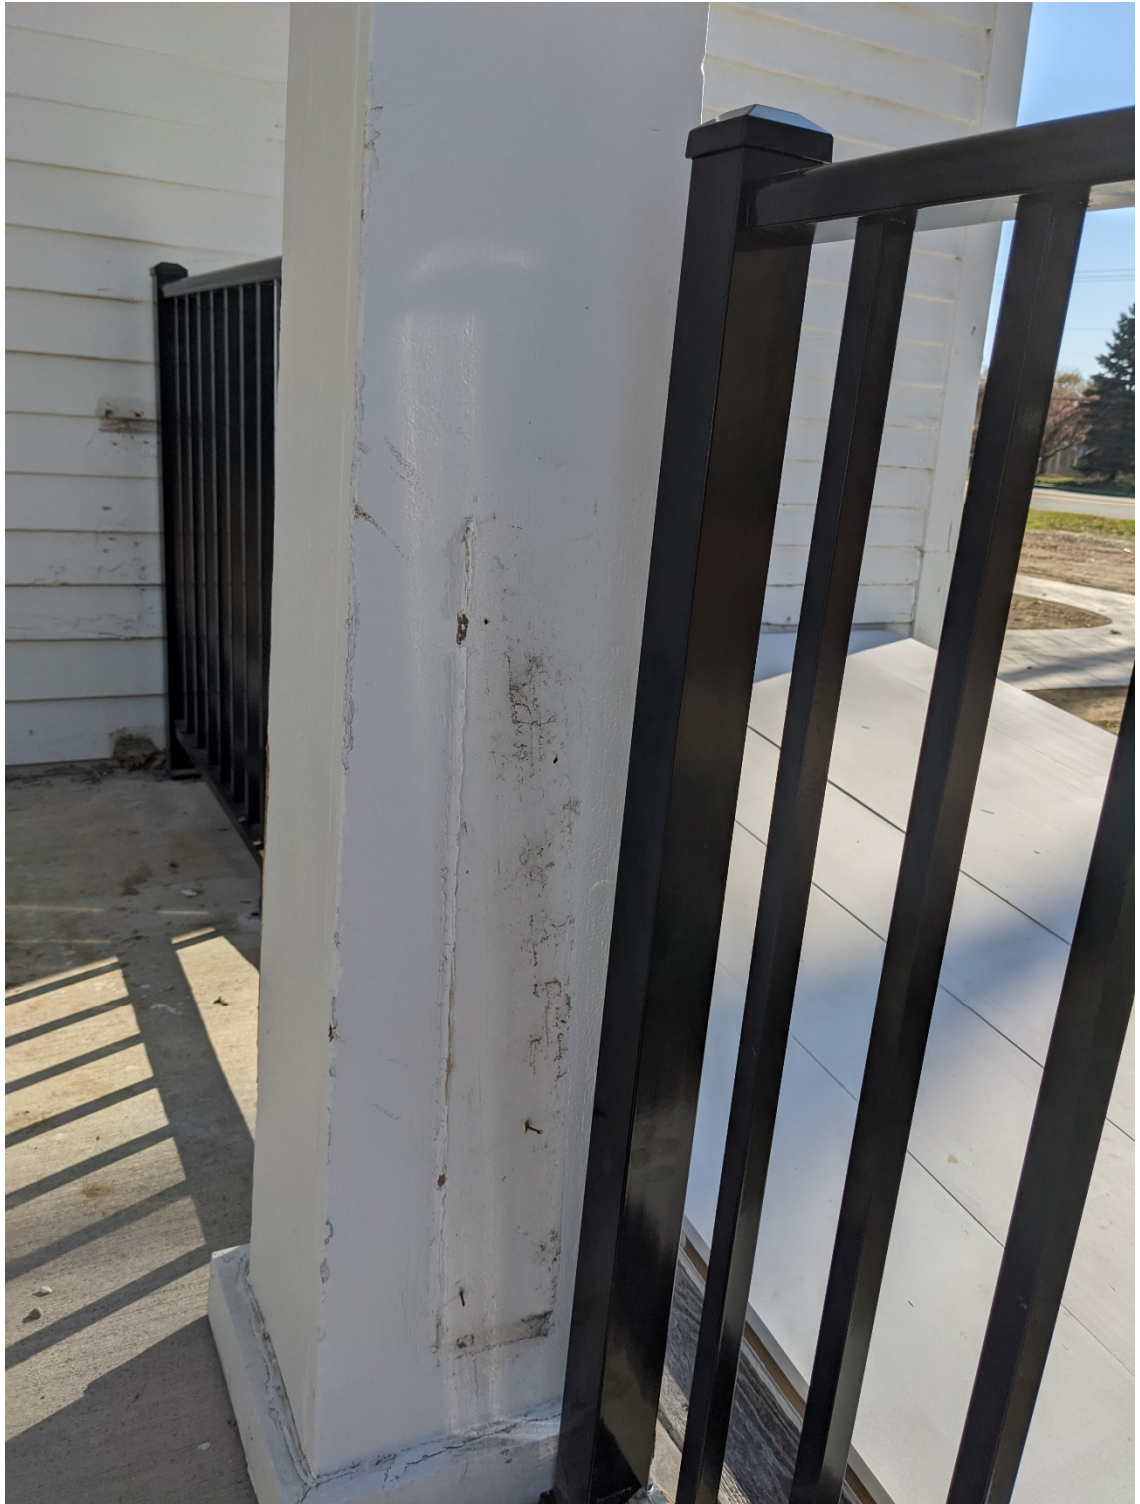
- a. Nail removal and painting needed at building and columns where existing railing removed from porch at door 101A**

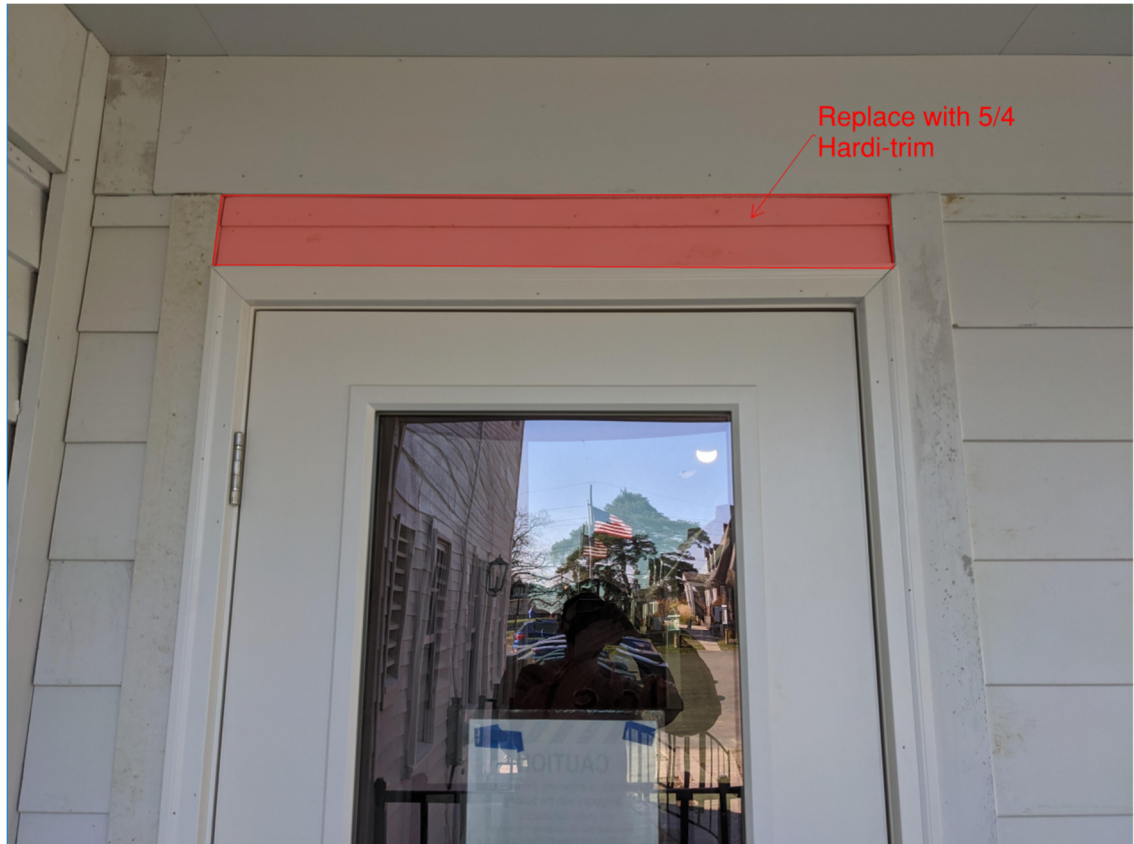
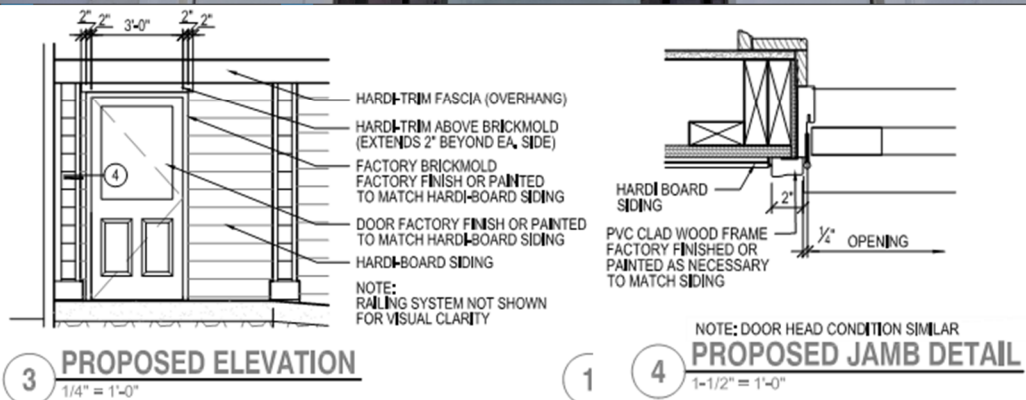
- b. Trim installation at door 114A differs from elevation supplied as part of “Submittal 016-R02 – 08 14 00 – Door 114A” Based on site discussion between architect, contractor and THV replace the siding above the door with 5/4 hardi-trim. Other trim may remain in place.

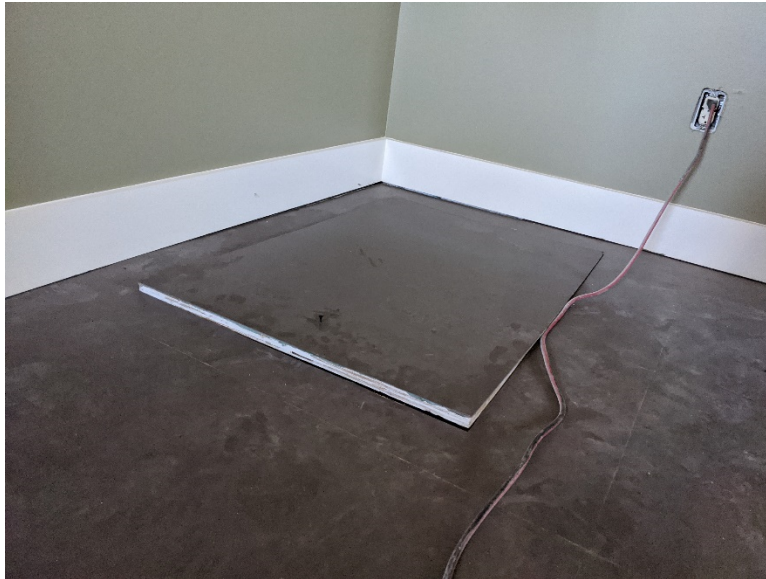
- c. **Crawlspace hatch difficult to install, linoleum overhangs hatch panel and is peeling from surface of panel. Chamfer edge of hatch panel as sketched below, trim linoleum flooring to extents of panel, install specified opening hardware.**
